Tacho Lycos  
2019 NASA Student Launch  
Flight Readiness Review Addendum

March 25, 2019

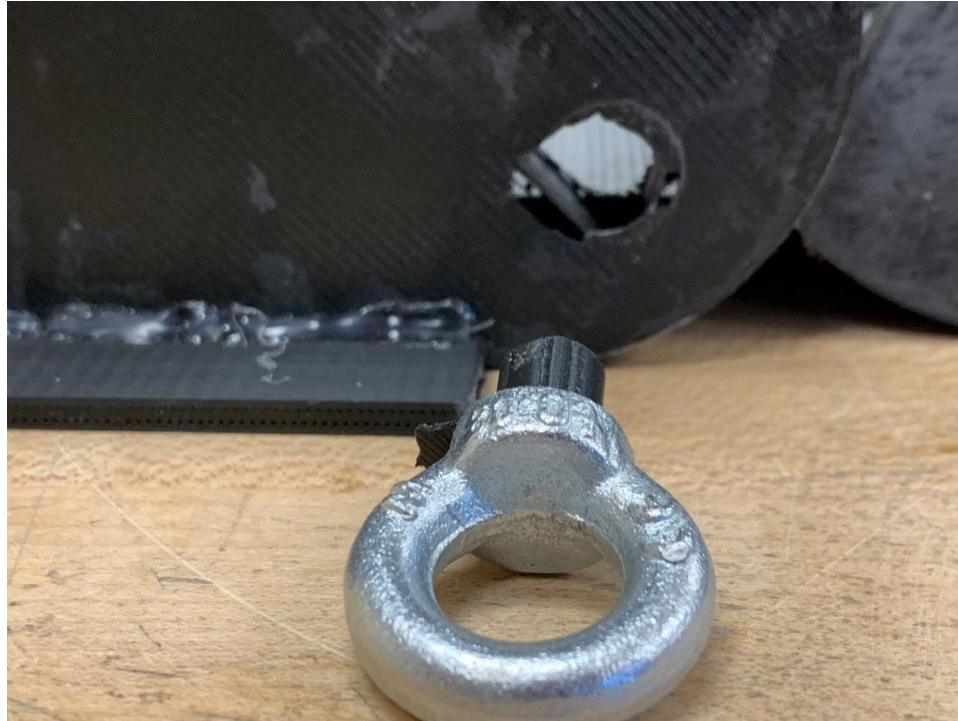
Figure 2-1 Damage to Payload Retention System

During the flight, the loading placed on the connection between the pod and latch was enough to break the eye bolt free from the pod. This left the pod secured by the friction of the centering rings, friction along the carbon fiber rod, and gravitational force directed by the vertical orientation of the payload bay. Additional flight or recovery event loading cause the pusher to break in shear, across the layers. This indicates that the loading was impulsive, as longer times would have allowed for delamination. The pusher and cantilevered carbon fiber rod remained attached and through the pod, and the pod was recovered while still present in the payload bay. On recovery, the pod extended from the aft most centering ring by 0.5 inches, which would not have been possible had the pod been attached to the latch.

While the pusher breaking has an impact on payload retention. The removal of the eye bolt due to flight loading is what ultimately frees the pod axially. Upon inspection after recovery, the eye bolt was still attached to the perimeter layers of the 3-D printed pod. This leads to the conclusion that the ultimate point of failure was the infill percentage of the pod. In a subsequent 3D print from the one tested, the infill percentage was lowered. While the overall material properties were considered, the effects of localized forces were not.

The eye bolt connecting the payload bay pod to the latch was severed completely from the pod. This damage, shown in Figure 2-1 requires that a new pod base be printed and attached to the pod. Additionally, the pod and eye bolt would be tested in accordance with section 6.1.5 of the FRR document.

The retention of the payload pod is a safety concern for personnel and spectators on the ground, which makes it an utmost focus for design. The payload pod has gone through many small design improvements, calling for it to be reprinted. The payload retention test was performed on the most updated pod at the date it occurred, which was not the same 3-D print as the one flown on the March 23<sup>rd</sup> launch. A change in infill percentage may have impacted the ability of the eye bolt and pod to withstand flight loads. The key takeaway for the team is to put into place administrative controls which ensure that a change in flight hardware calls for a re-test of related requirement verification tests. This lesson learned is echoed in the discussion of the payload electronics in Section 2.2.5.

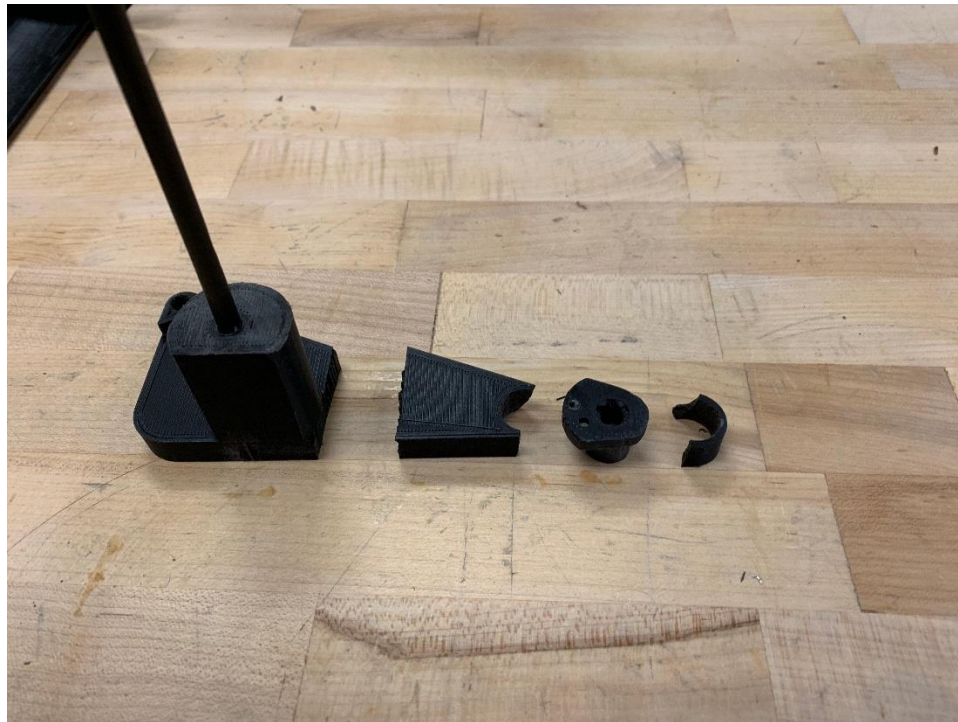
Figure 2-2      Damage to Payload Pusher

As described in section 2.1.3 above, the pusher, designed to use the spinning lead screw to deploy the pod, was sheared into 3 parts, making it incapable of completing its mission. The shock cord may have interfered with the pod opening, but as the pod had to be removed manually, this was not tested on launch day.

The pusher was the only part of the payload that was damaged in a way that requires replacement. Figure 2-2 shows the damage to the pusher. The pusher is constructed of 3D printed PLA plastic with a carbon fiber rod press fit into the center and a plastic nut for interfacing with the lead screw, press fit into its lower portion. Replacement consists of reprinting the plastic portion and pressing a new carbon fiber rod into place. This would be followed by testing of the payload deployment process to confirm proper functionality of the new pusher.

The fractured state of the payload pusher caused the team to question its design and construction; though without further testing, the following claims are merely conjecture. The nature of the press fit between the plastic nut and the pusher likely subjected the plastic in that area to some amount of preloaded tension. The fractures in this region, shown on the right side of Figure 2-2, suggest that the payload pod was forced towards the aft end of the payload bay; an event that is associated with the firing of the main parachute ejection charge. With the eye bolt connection severed, this would have exposed the region of the pusher around the lead screw to a bending moment. This, coupled with the preloading associated with the press fit, is likely the failure mechanism that compromised the pusher. For future projects involving 3D printed parts, the team shall exercise caution when using construction techniques such as press and interference fits. The team shall use finite element analysis to better understand the internal stresses imposed by these techniques and, where able, use chemical adhesives that better exploit the strengths of 3D printed building materials.

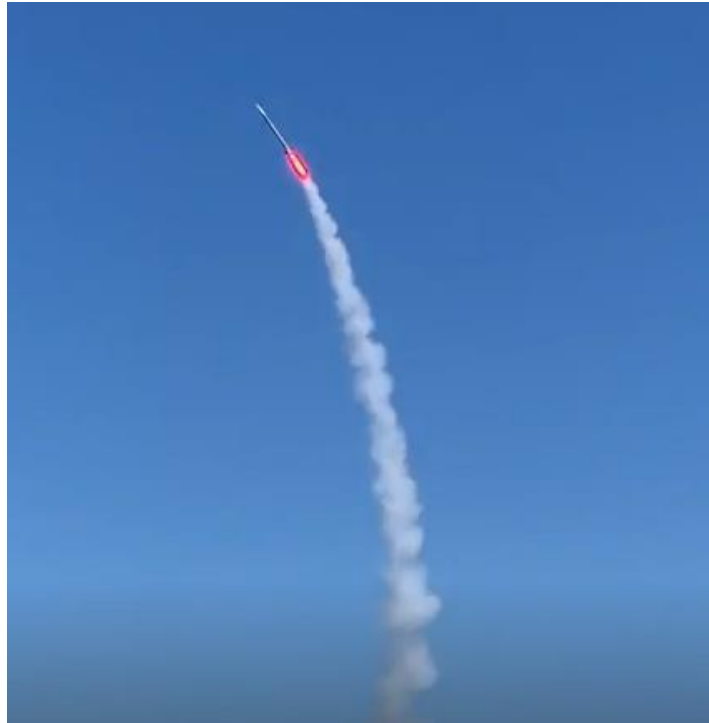
Figure 3-1 Launch Vehicle Flight Path Shortly After Takeoff

Despite the team's efforts to prevent weathercocking, the launch vehicle still exhibited severe weathercocking in the moments shortly after rail exit. The launch rail was angled 3 degrees away from the wind. Figure 3-1 shows the launch vehicle pointing into the wind at an angle of 33 degrees with respect to vertical. The launch vehicle was launched from a 10 ft launch rail mounted to a launch pad of sturdier construction than the one used previously. This was done to prevent weathercocking due to a low rail exit velocity. It is clear that these measures were insufficient to prevent weathercocking. However, the results of this launch suggest that this trajectory does not inhibit the launch vehicle's ability to be launched and recovered safely.

The results of this launch suggest that the rocket, in its current configuration, will weathercock dramatically in windy conditions. This will greatly impede the team's chances of achieving the apogee goal of 4090 ft. Based on the results of this flight and the team's first flight, even light winds will result in the launch vehicle failing to reach a scorable apogee. The team's mentors have advised that in the future, the team opt for larger fins as well as a motor that provides a higher thrust to weight ratio to prevent this issue. While these changes cannot be applied to the current launch vehicle design, the team intends to implement them as best practices in future years. Additionally, the team is exploring the possibility of acquiring another motor for testing by the team's mentors who are both members of the Technical Advisory Panel of TRA. Due to the limited availability of L-class motors at this stage of the competition cycle, the team is unable to pursue such testing at this time.

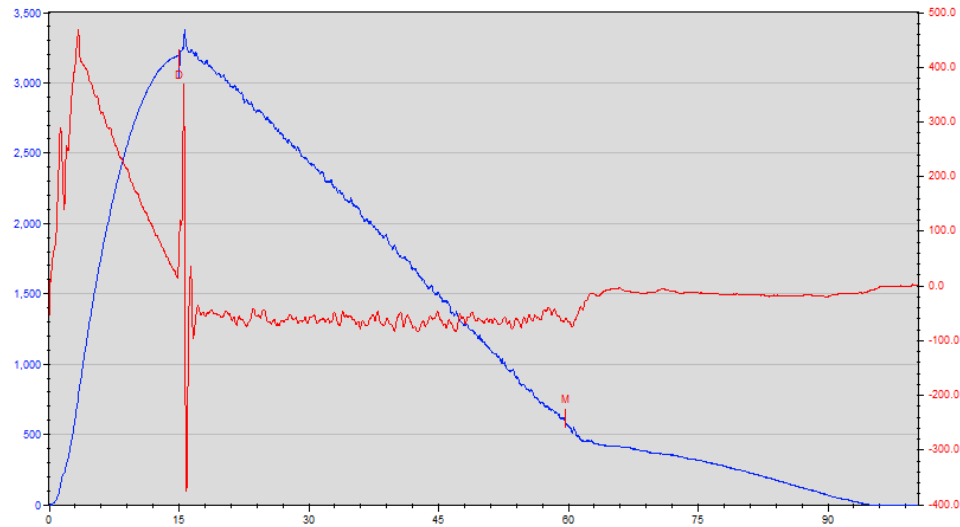
Figure 3-2 Flight Data from Primary Altimeter

Figure 3-2 shows the data extracted from the primary altimeter. Apogee was recorded at 3192 ft AGL. Top speed was recorded at 480 fps. This data also shows that the launch vehicle descended under drogue at a speed near the estimated 71.5 fps. Additionally, the descent rate under main was found to be near the previous result of 17 fps.

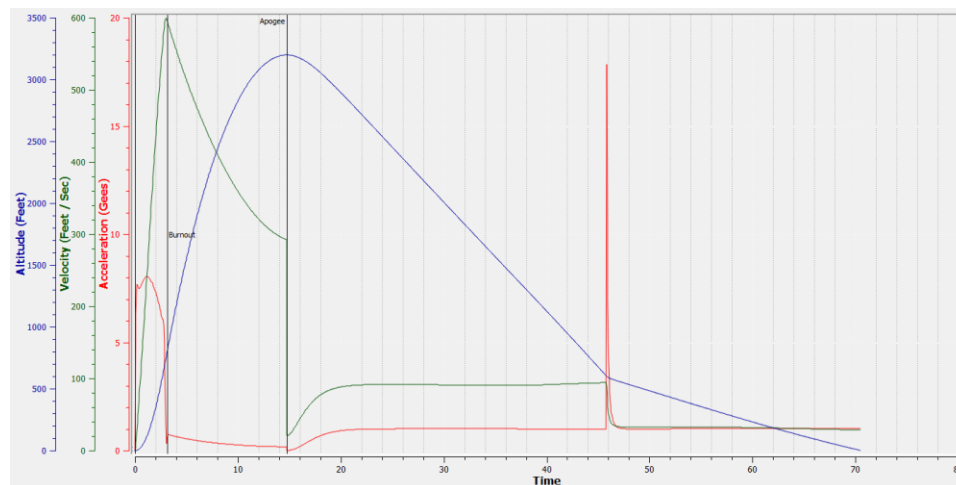
Figure 3-3 RockSim Post Launch Flight Analysis

The launch vehicle left the rail at a velocity of approximately 69.25 feet per second which is comparable to the RockSim model of 64.45 feet per second. After exiting the launch rail, the launch vehicle weathercocked into the wind at approximately 33 degrees off vertical in a span of approximately 2 seconds. After picking up speed, the launch vehicle traveled along a straight trajectory towards its final apogee of 3192 ft. Wind conditions at launch were measured as 10-14mph on the ground. At the time of launch, the Coastal Carolina Regional Airport in New Bern, NC report a density altitude of -75 feet MSL on its Automated Weather Observing System (AWOS). These observations were used to create a post-flight simulation in RockSim. Figure 3-3 shows the results of this simulation.

The data in Figure 3-3 was generated after first adjusting the drag coefficient of the launch vehicle to reflect the flight data in Figure 3-3. The drag coefficient was found to be 0.365.

This is lower than the previous estimate of 0.55 in the FRR. This change is due to the team's increased confidence in the early flight conditions of the launch vehicle. Specifically, the team is confident in the accuracy of the measured wind conditions, the launch rail exit velocity and the angle of the launch vehicle shortly after takeoff.

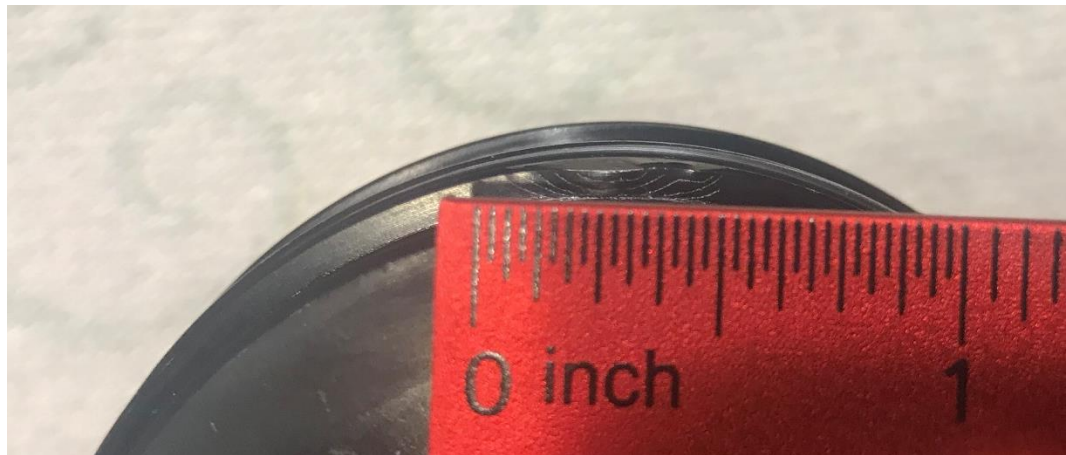
Figure 3-4 Damage to Motor Casing Forward Closure

After inspecting the launch vehicle, it was determined that no components of the launch vehicle require repair or replacement. However, inspection of the motor casing after launch revealed an indentation in the forward closure that was not present before launch. Shown in Figure 3-4, this indentation extends into the area normally occupied by the forward seal O-ring. This O-ring is necessary for maintaining stable pressure within the casing during the motor burn. After consulting with the team's advisor and mentor, the team has elected to replace this forward closure with an identical, but undamaged, forward closure for any future flights. Furthermore, the damaged flight article has been marked inoperable and shall not be used in any future launches.
