Tacho Lycos
2021 NASA Student Launch
Flight Readiness Review Addendum

High-Powered Rocketry Club at NC State University
911 Oval Drive
Raleigh, NC 27695

March 29, 2021

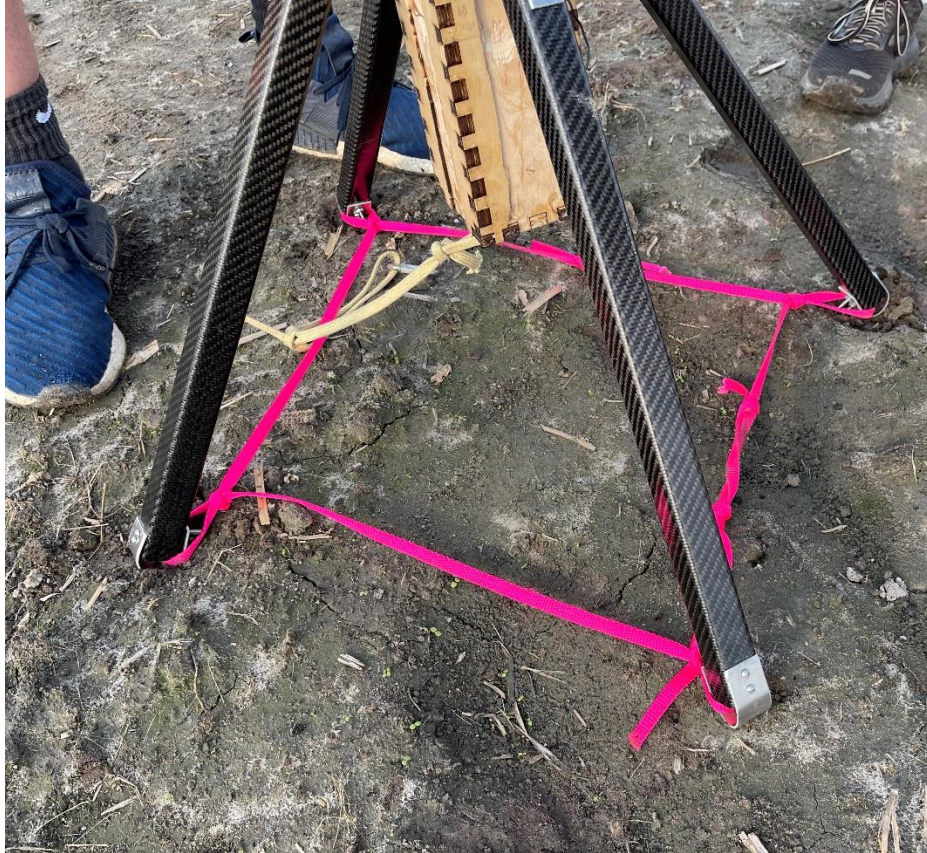
Figure 1-1 Leg Shock Cords

Another change was made to the leg splay angle system. Two torsional springs force the legs to splay out. The original intention was to set the leg splay angle to a fixed angle using a cable that wrapped behind the leg mounts on the outer ring. The team had designed this system to use a 1/16" steel cable. The cable that the team selected was not strong enough to endure the forces encountered by the legs. Multiple tests were conducted to see how the cable would react. The cable would stretch considerably and then break. This meant that not only could the legs not be set to a desired angle because the stretching would change that angle, but they would not be able to withstand landing forces and the payload could not land evenly. The solution to fix this problem was to increase the cable strength by braiding it and treating it as a shock absorber. The stretch would help absorb some landing energy, but the legs would not be entirely reliant on the cables. Neighboring legs were tied to each other using short lengths of shock cord. This also helped to set the leg splay angle but was much stronger than the braided cables, so that LOPSIDED could land on impact and not be destroyed.

The benefit of the design using the shock cords to set the legs is that the splay angle and elasticity/shock absorption can be modified. The shock cord could be tied with longer lengths between the legs to increase the leg splay and there for the landing footprint decreasing the chances of tipping.

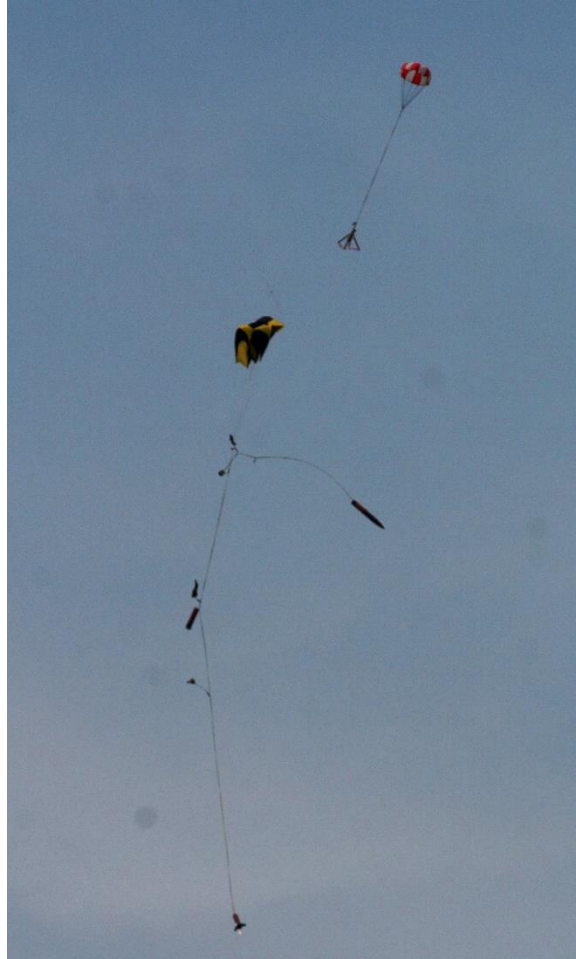
Figure 2-2 LOPSIDED-POS Descending Separately from Launch Vehicle

As seen in the Figure 2-2, the ARRD deployed as intended. The pin and toggle were detached from the ARRD and remained attached to the main parachute shock cord. It is also seen in Figure 2-2 that the electromechanical lock on the left deployed while the electromechanical lock on the right remained attached to the parachute. The lock on the right remained attached to the parachute due to the zip ties preventing the lock from unlatching. This is due to strength issues discovered during drop testing that are discussed later. The lock on the left released its locking pin and therefore that side of the parachute connection before touchdown off the payload. The team knows that the lock released before landing because the pin could not be found near the payload landing area. This means that the team made the correct decision to secure the other lock with zip ties to ensure that the payload would not drop away from the parachute prior to landing.

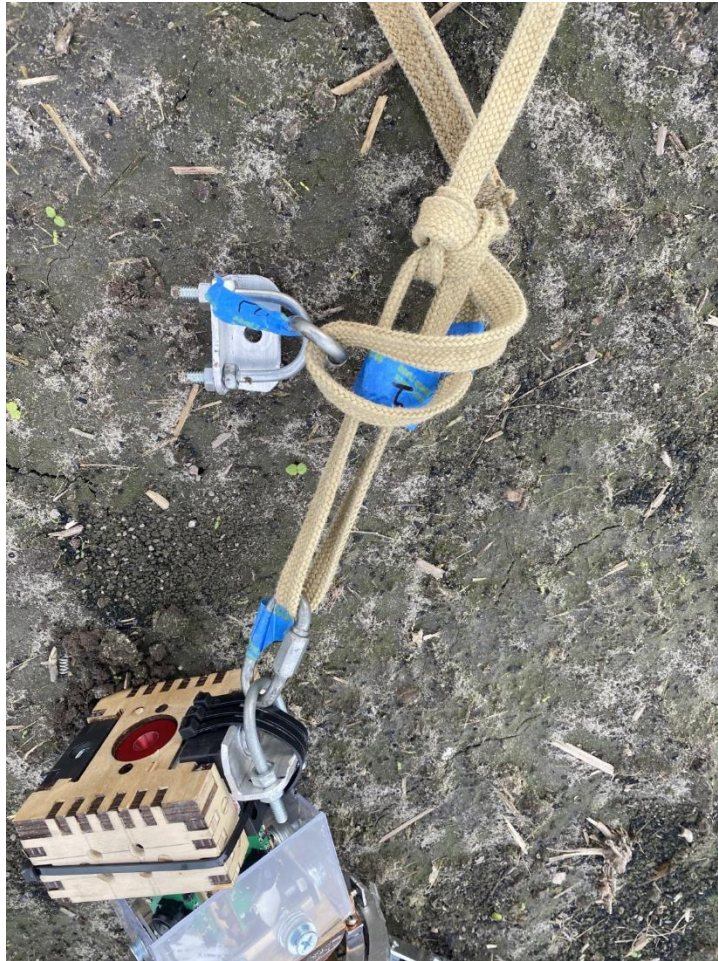
Figure 2-5 Electromechanical Locks, U-Bolt with Pins, and Payload Shock Cord

The second system is the ARRD. The ARRD was attached to the top of the payload as seen in Figure 2-5. Through a pin and toggle, it connected the payload to the main parachute shock cord. The ARRD works with black powder so that with the signal from the electric charge from an altimeter on the LOPSIDED electronics sled ignites the ARRD black powder. The spring test was implemented when assembling the ARRD. The spring test is to test with one's own fingers that the spring can be pushed in so that the pin can be released. If the spring test passes that means that the black powder can raise enough pressure so that inside the red can, the push cap can be pushed, and the spring can be free. This system worked as intended, which completes the deployment system, and it is recognized as a successful payload deployment.

The last system for payload integration and deployment is the parachute release devices. The parachute release devices are currently the two electromechanical locks. These locks were successfully tested for the drop test; however, they began to free the pin when it was not intended to free. This may be because the pins have a little bit of wearing on them from past uses either from testing or from adjusting the pin to the latch. In addition, one of the pins got lost during the payload demonstration launch. This leads the team to either make another pin or replace one electromechanical lock with a rotary latch. Currently both electromechanical locks do not work as intended as the locking pins can be removed simply by jostling them. A solution to this issue was to use zip ties on the latches and on the U-bolt that attaches to the parachute so that the lock would not release at all; this ensures that the lock is always attached to the parachute. It was required to keep the parachute permanently attached to the payload given that the electro mechanic locks could not be trusted with deploying at the intended time of landing. A solution for next launch could be to adjust the pins so that it cannot wiggle or replace one of the electromechanical locks for an extra rotary latch. The rotary latch is a more robust system that will also release the parachute more reliably as it does not have a pin that needs to be pulled by the payload parachute.

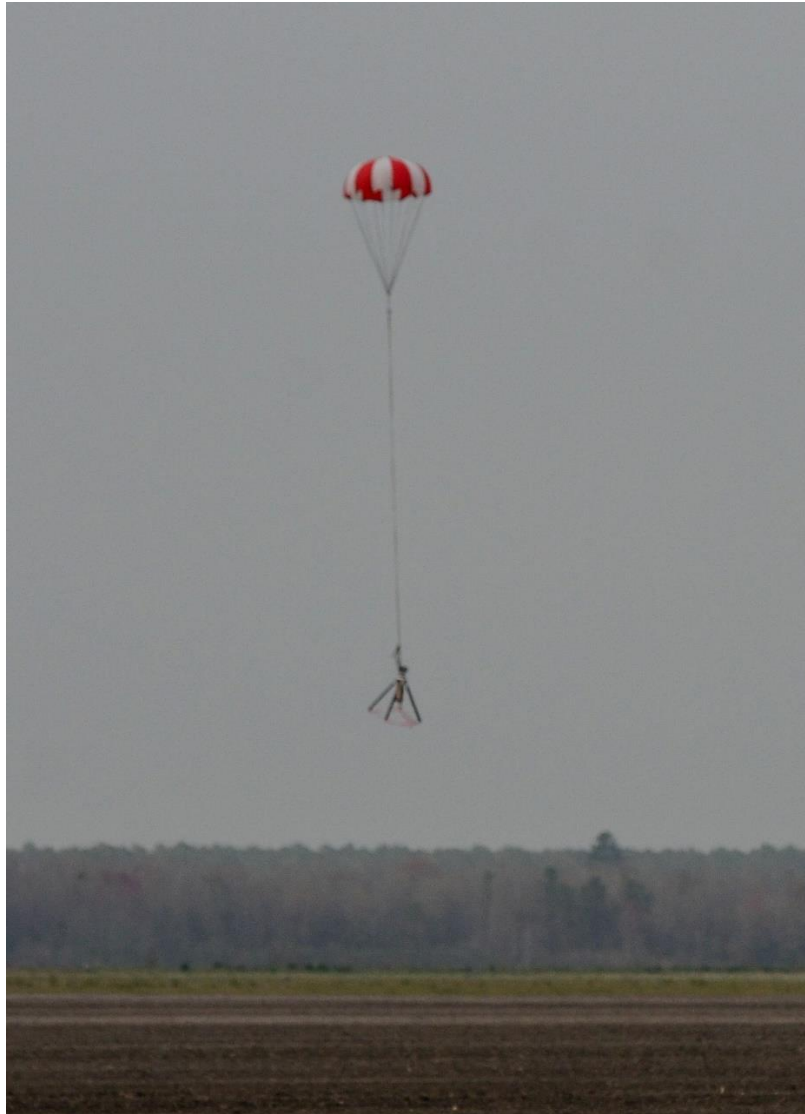
Figure 2-6 LOPSIDED Descending

LOPSIDED was successfully removed from the payload bay without any interference caused by the legs. It survived all the forces that were planned for: the launch/vibrations, the deployment/ejection, the opening parachute shocks, and the landing force.

The landing conditions were ideal, although it was most likely coming down faster than predicted, it still survived the landing and is in condition to fly again. There was very little wind and horizontal velocity which was the team's main worry about the payload being able to land upright.

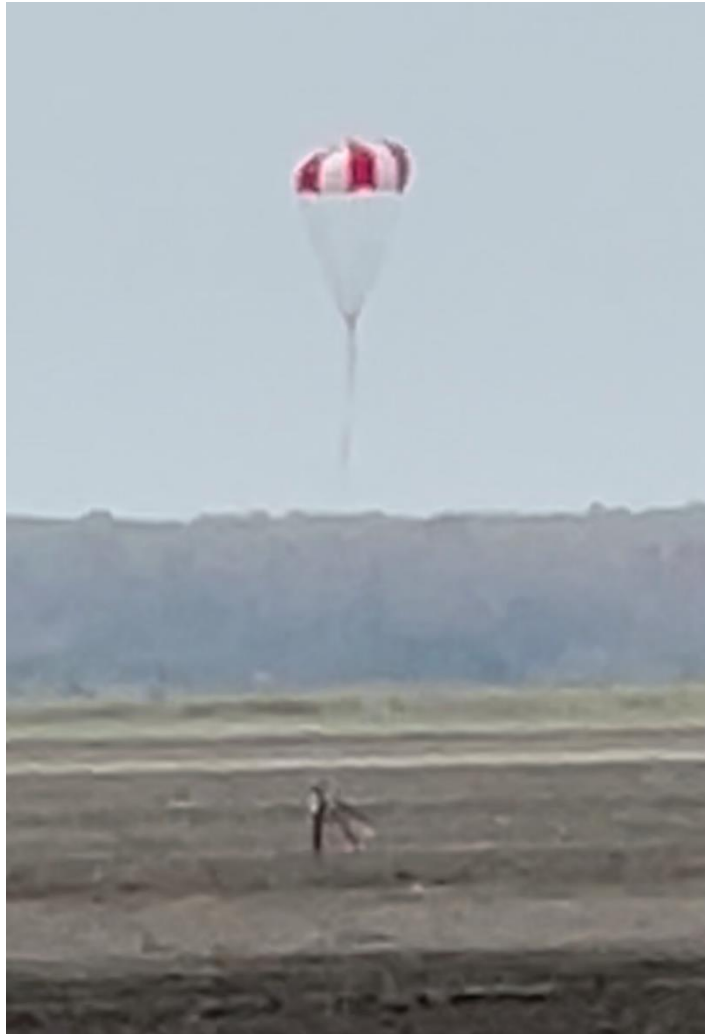
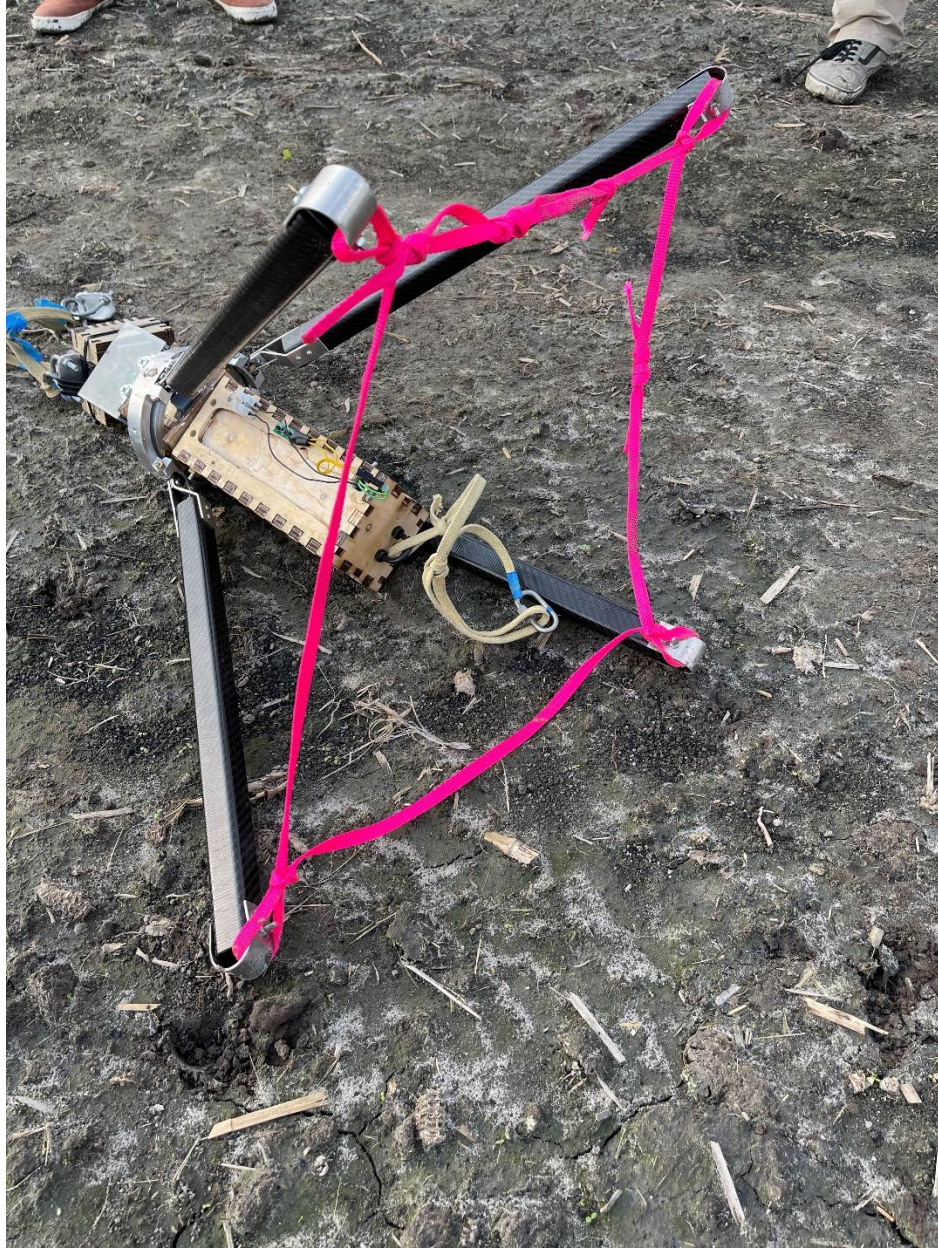
Figure 2-7 LOPSIDED Tipping on Landing

Even though LOPSIDED had ideal landing conditions, it was moving fast and had very little shock absorption. The payload landed on all four legs and did not dissipate enough energy, it bounced back up and was pulled over its legs and settled on its side. Figure 2-8 shows the configuration after landing. In this picture it is shown that the legs hit the ground considerably hard, the four locations where the legs impacted had visible craters in the ground where each of the feet dug up the dirt. The payload falling over means that the leveling rings could not be tested to validate the vertical alignment tilting.

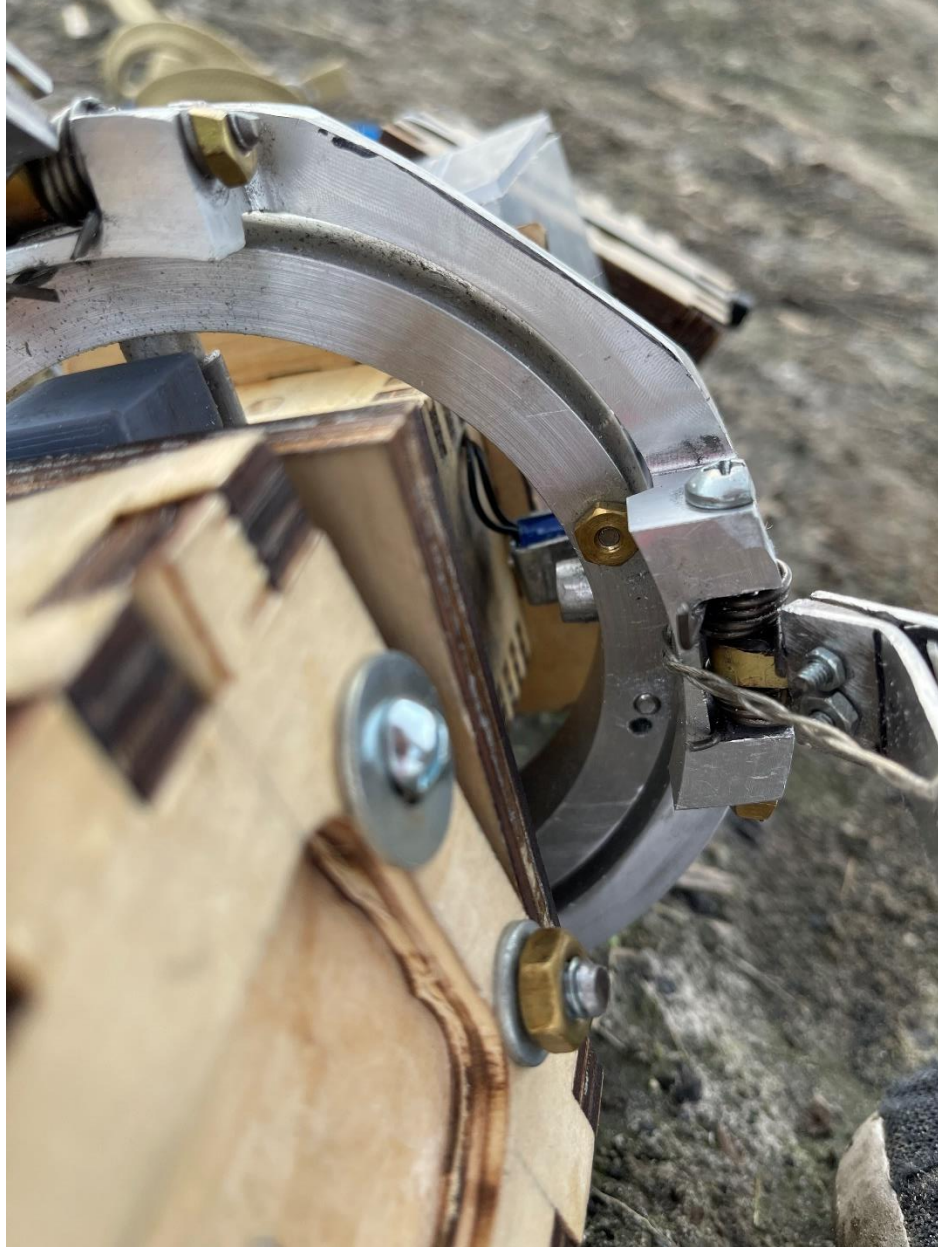
Figure 2-9 Loose Solenoid Bracket Bolt and Nut

While all the solenoids and their mounts survived the fall, some of their nuts that were retaining them were loosened. This was most likely due to the team underestimating the vibrations from the launch and will be tightened better for the final launch.

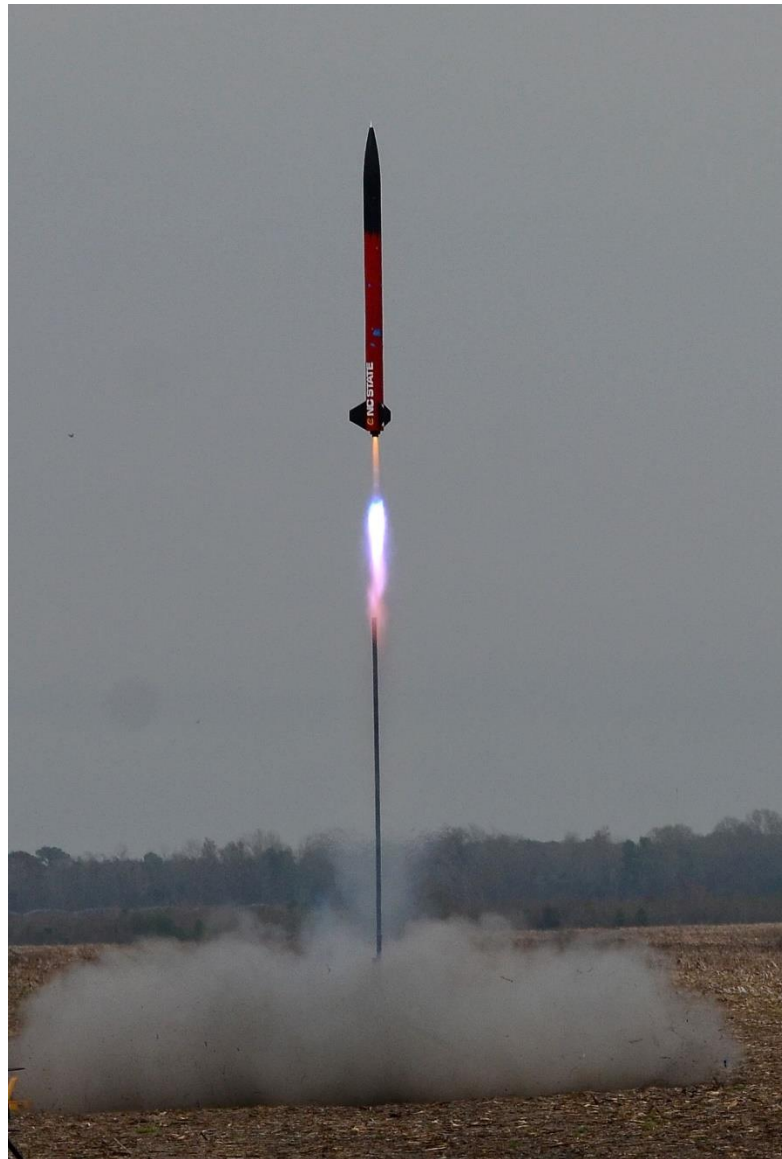
Figure 3-1 Launch Vehicle departing Launch Rail

The flight was in many respects a success, although a partial failure occurred within the recovery system resulting damage to the main parachute. Figure 3-1 below shows the launch vehicle departing the launch rail.

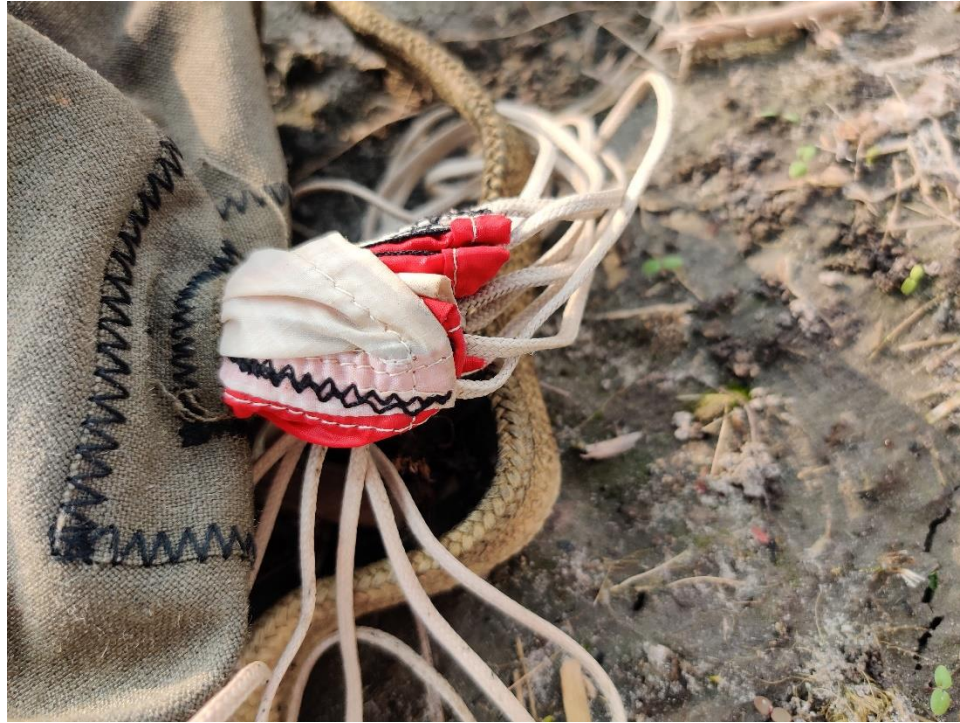
Figure 3-2 Drogue Parachute at Field Recovery

A single deviation from the nominal recovery sequence caused a cascading failure within the recovery system. The drogue parachute shroud lines and the base of the parachute were pulled through the attachment hole in the Nomex sheet used to protect the parachute during deployment preventing the drogue parachute from inflating. The cause of this failure is currently unknown, as no changes have been made to the successful drogue recovery harness assembly

since the initial, successful vehicle demonstration flight. Currently the team's most plausible theory is that the parachute got jammed into the Nomex sheet during assembly of the drogue parachute. To prevent recurrence of this failure, the sheet will be attached to the drogue quick link. This will securely tether the Nomex sheet to the base of the drogue parachute shroud lines and eliminate any chance of this failure mode occurring again.

As a result of the failure of the drogue parachute to fully inflate, the launch vehicle was not stabilized during the first stage of its descent. This caused the more massive forward assembly to descend below the fin can. Analysis of video taken by team members clearly shows this during the main parachute deployment sequence. When the main parachute deploys from the forward assembly, the fin can continues falling at the drogue descent velocity. Video footage clearly shows the fin can and drogue shock cord impacting the main parachute shroud lines, and the resulting severing of the shroud lines. The field recovery team observed this damage to the main parachute shroud lines upon arrival at the landing site. This can also be seen in Figure 2-2 where the damaged shroud lines are present above the main (black and yellow) parachute canopy. No other damage beyond the damage to the main parachute shroud lines was sustained by the launch vehicle as a result of this failure.

Several critical lessons were learned during this flight. The Nomex sheet will be constrained to the drogue parachute attachment quick link in future flights to prevent this tangling from occurring. This failure point resulted in the loss of the main parachute and a partial recovery system failure. A minor problem encountered at the launch was a difficulty arming screw switches within the launch vehicle body, with the AV sled not remaining aligned with the switch ports in the launch vehicle body tube. Alternatives to this style of switch should be evaluated for future systems. The overall nature of these issues and the team's confidence in the solution to these issues gives the team confidence in missions success for the competition flight. Most importantly, this flight validated the performance of the extended main parachute bay, shortened forward AV bay coupler, and rearranged components on the main parachute recovery harness discusses in the FRR document.

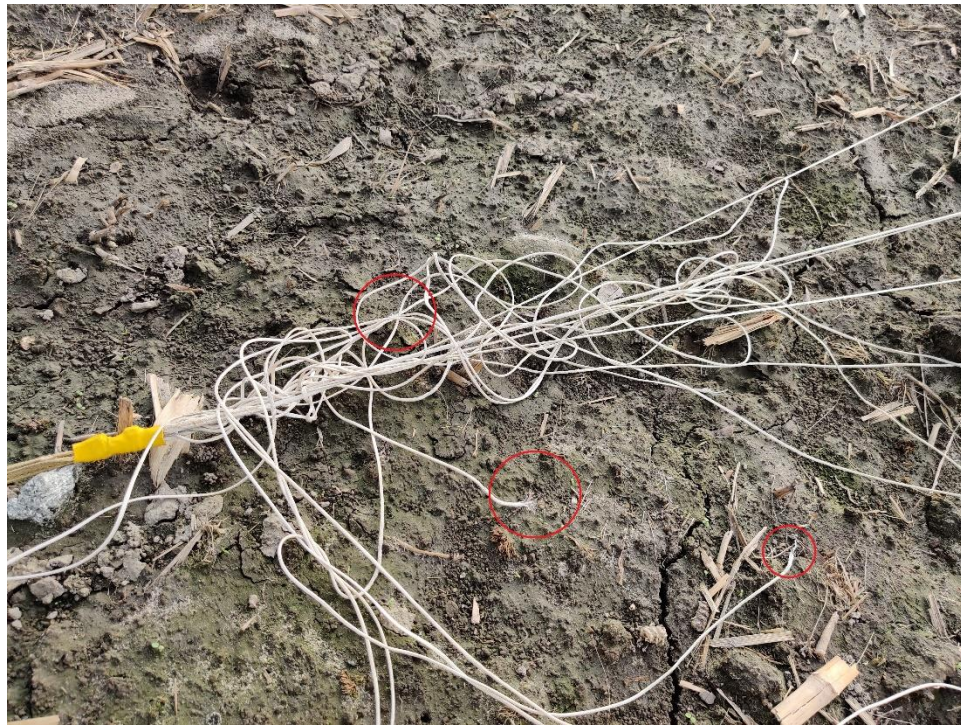
Figure 3-5 Severed Main Parachute Shroud Lines

The most significant launch vehicle hardware damage was to the Fruity Chutes 120" Iris UltraCompact main parachute during the main deployment sequence. Several shroud lines were severed as circled in red in Figure 3-2 below.

The severed shroud lines resulted from the impact with the free-falling fin can described in Section 3.1. This cascading failure did not result in any other damage to the launch vehicle.

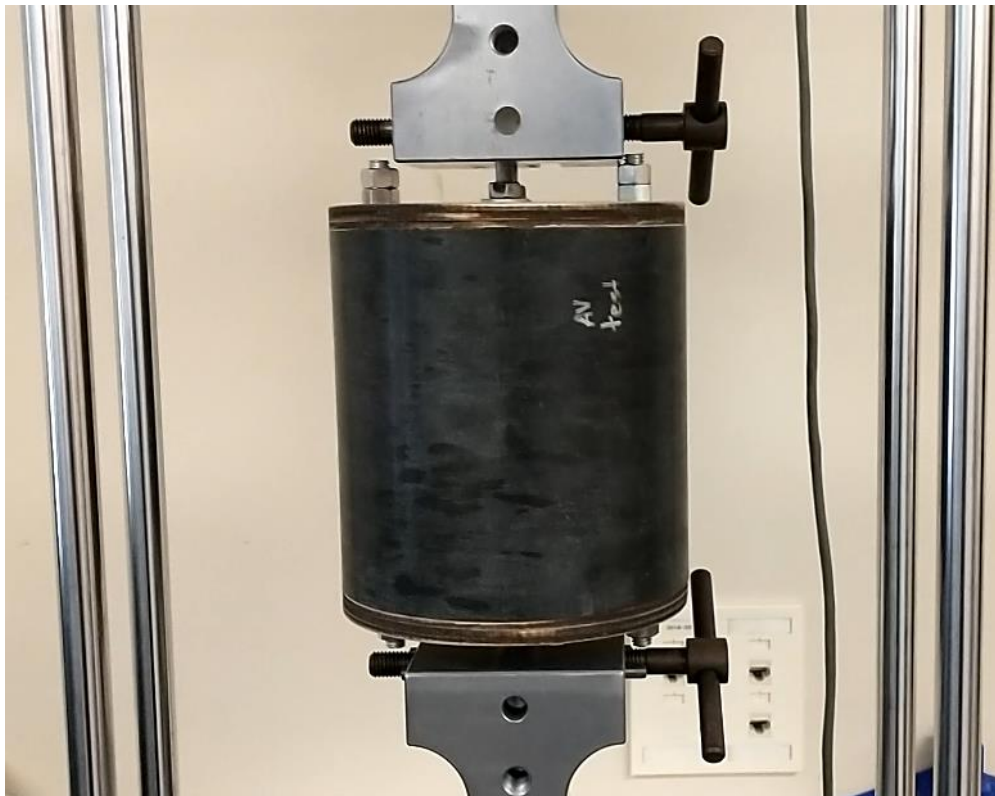
Figure 4-2 AV Bulkhead Test Setup

While setting up the test piece, the zeroed load value was recorded at 0 lbf with an error of ± 3 lbf. At a loading of 650 lbf, the test piece showed no visible signs of damage. The loading was continually increased to the machine's maximum loading of 1000 lbf, but the test piece still showed no visible damage when removed. This means the design has a factor of safety of at least 3.06 which exceeds the value required by TDR 2.2.

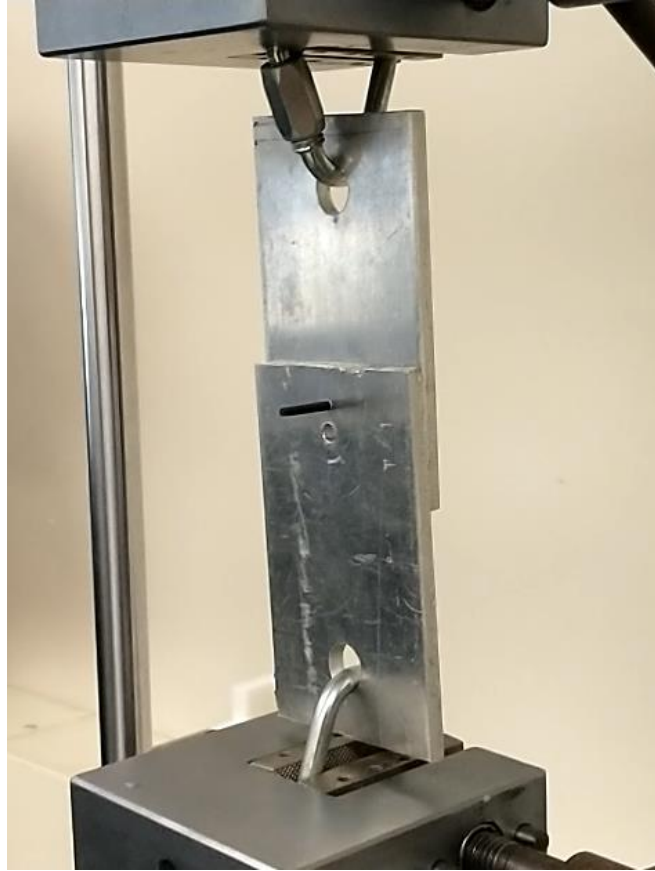
Figure 4-3 Shear Pin Test Setup

While setting up the shear pin test piece, the zeroed load value was recorded at -8 lbf with an error of ± 3 lbf. As the applied loading increased, the shear pin seemed to stretch until it failed at 32 lbf, or 40 lbf including the zeroed load. Because shear pins are typically broken at a high velocity, the team altered the test procedure to reflect this for a second shear pin. This time, the applied force was set to 100 lbf so it could be tested straight to failure and the testing machine's display was recorded to find the point at which it failed. This time the shear pin failed at 34.8 lbf, or 42.8 lbf including the zeroed load. Although the shear pins failed around 40 lbf instead of 35 lbf as expected, this will not be an issue. The force exerted on the shear pins by the expanding gases is far higher than their combined strength meaning that they will still fail even though their strength is slightly higher than expected.

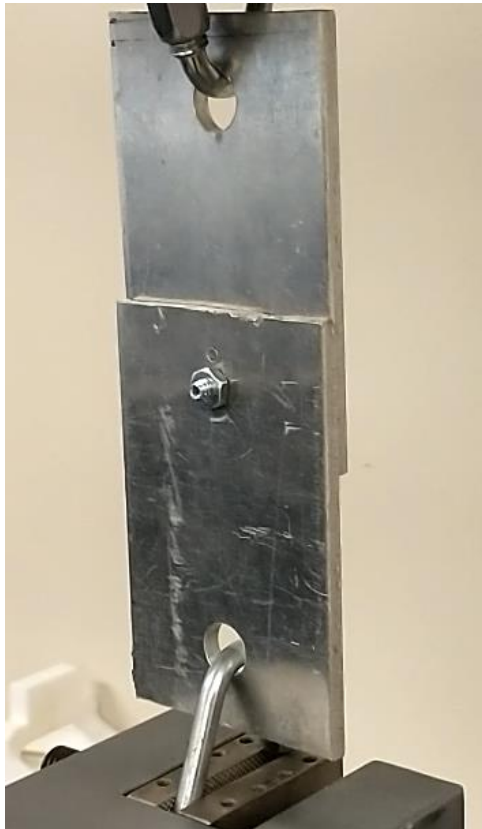
Figure 4-4 Fastener Test Setup

While setting up the fastener test piece, the zeroed load was recorded to be -8 lbf with an error of ± 3 lbf. The bolt showed no damage at a loading of 180 lbf so the loading was continually increased. Once it hit 800 lbf, the bolt failed. Since it failed so high above 174 lbf, the second bolt was tested straight to failure. The machine was set to 1000 lbf and the display was recorded to find the exact failure point. The bolt failed at 813 lbf, or 821 lbs including the zeroed load. This gives the bolts a factor of safety of 9.44 which meets TDR 2.2.
